**Elite Home Inspections**  
A DIVISION OF  
*Elite Construction Services LLC*

# Property Inspection Report

5896 Greenview, Webster , NM 88569  
Inspection prepared for: Samuel Jones  
Real Estate Agent: Doe Jane - Exit Realty

Date of Inspection: 6/22/2022 Time: 10 AM  
Age of Home: 6 Size: 3600  
Weather: Cloudy

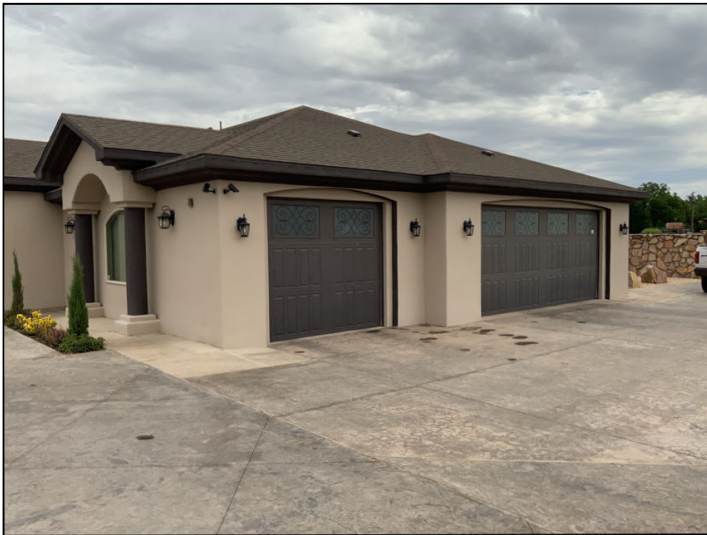
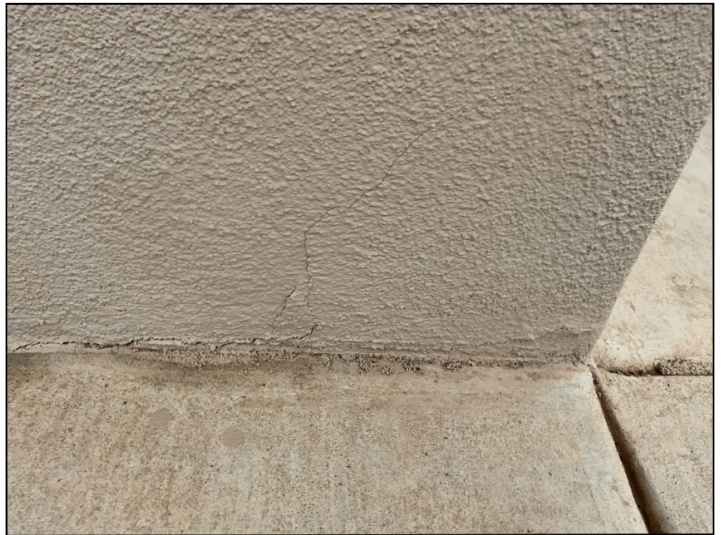
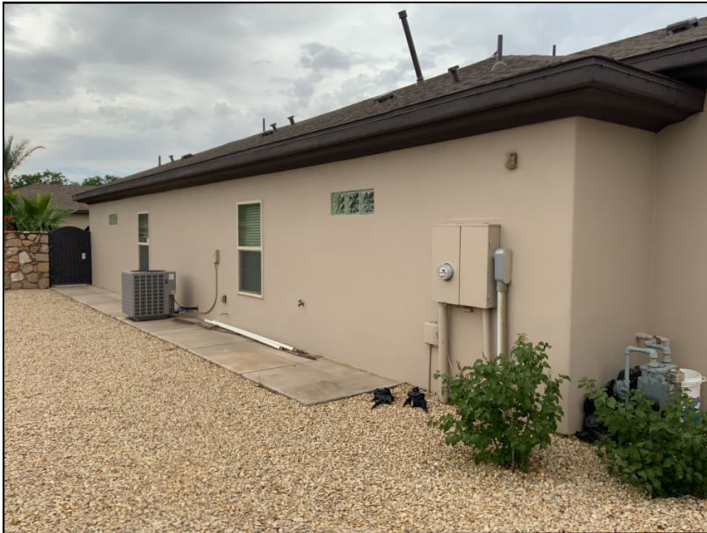
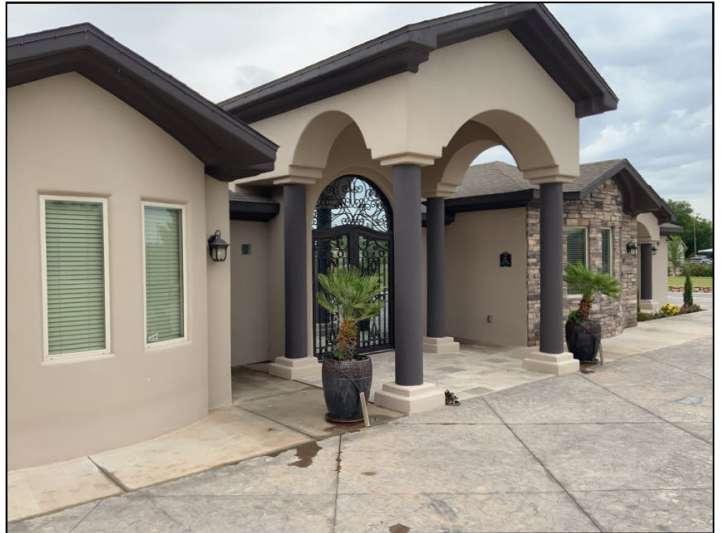
- **\*\* STUCCO \*\***
- Typical cracks evident.
- Recommend caulk and seal all gaps, cracks and openings.

Typical Cracking of stucco, needs repairs

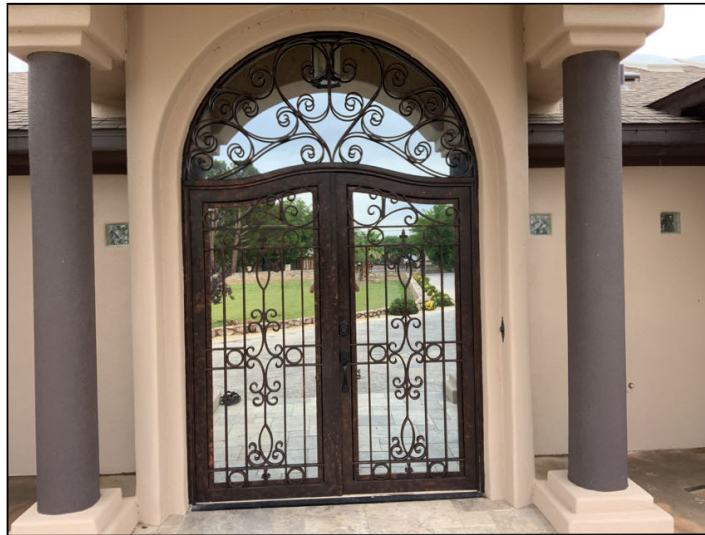
- Door in satisfactory condition at time of inspection.
- Door hardware, hinges, and locks in satisfactory condition at time of inspection.
- Door sticks, needs adjustment.
- Door requires adjustment to latch properly. Repair as needed.

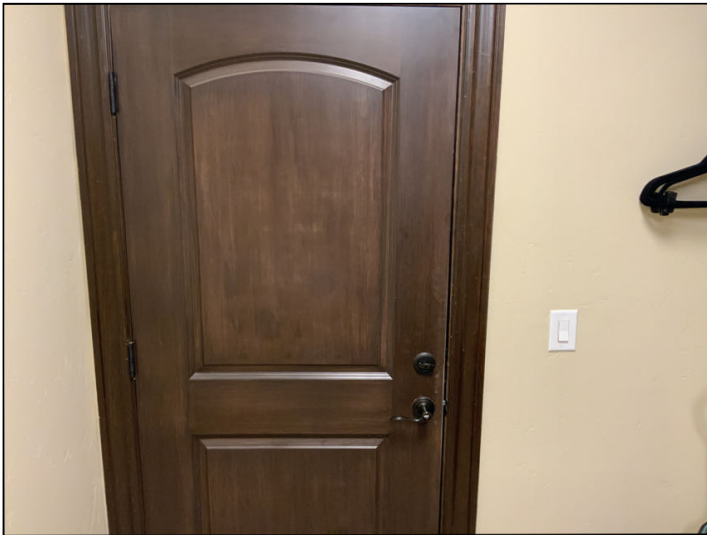
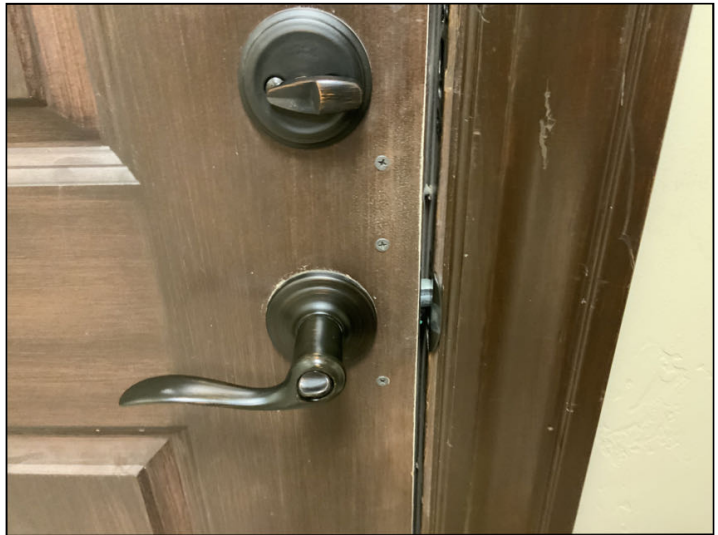
- Door in MARGINAL condition at time of inspection.
- Self-closing hinge NOT installed and operational at time of inspection. Recommend installing.

Screws present of both sides of door

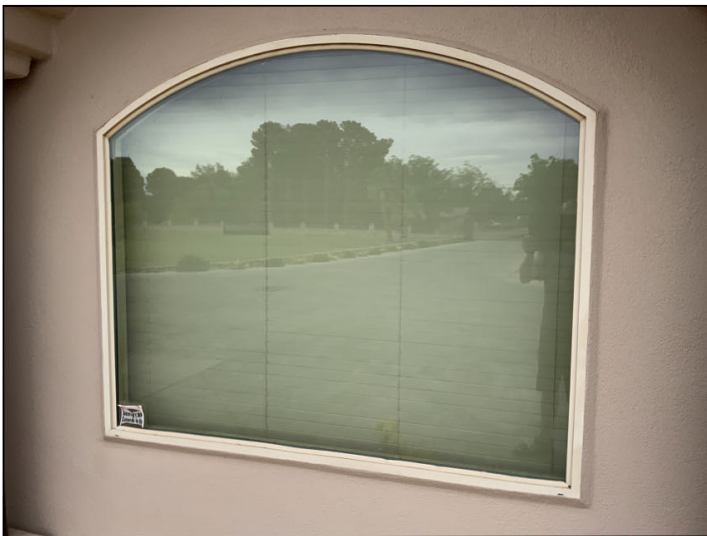
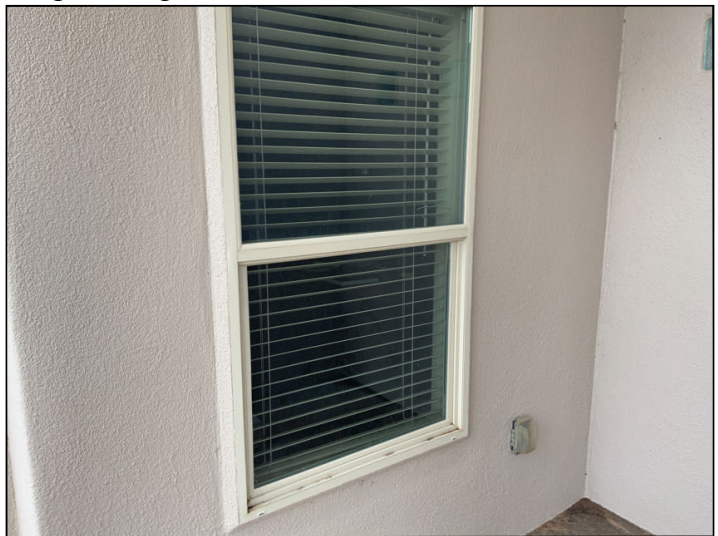
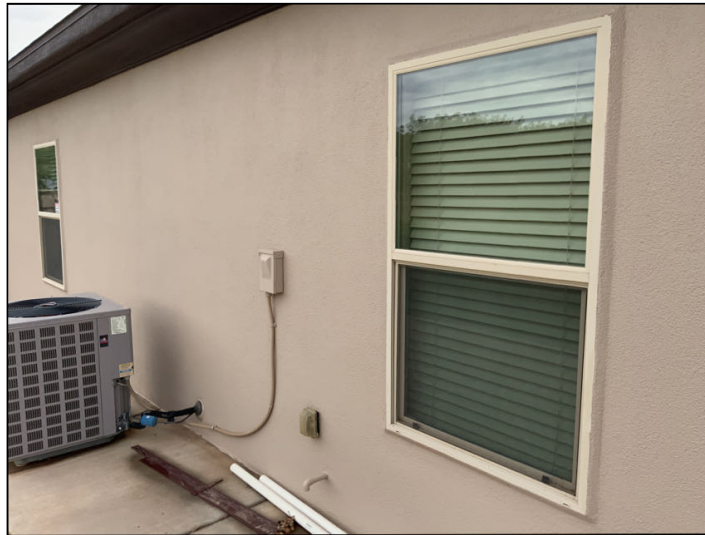
- Screens appeared in satisfactory condition at time of inspection.
- Some window screens missing/damaged.

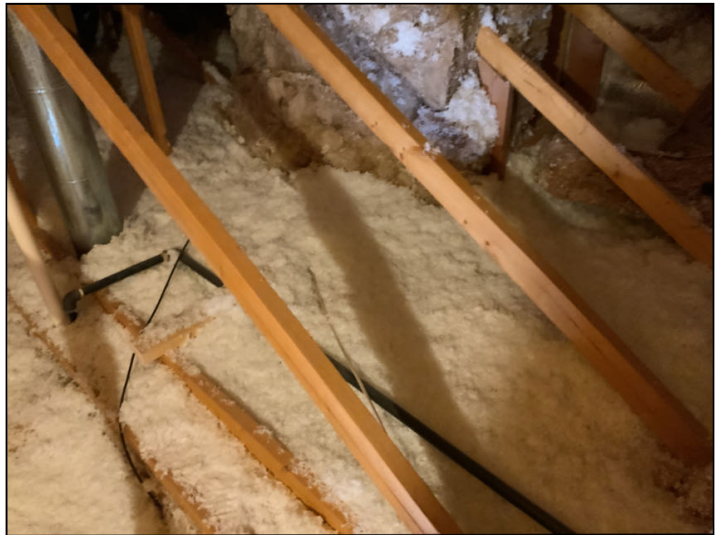
- Insulation is sparse in some areas.

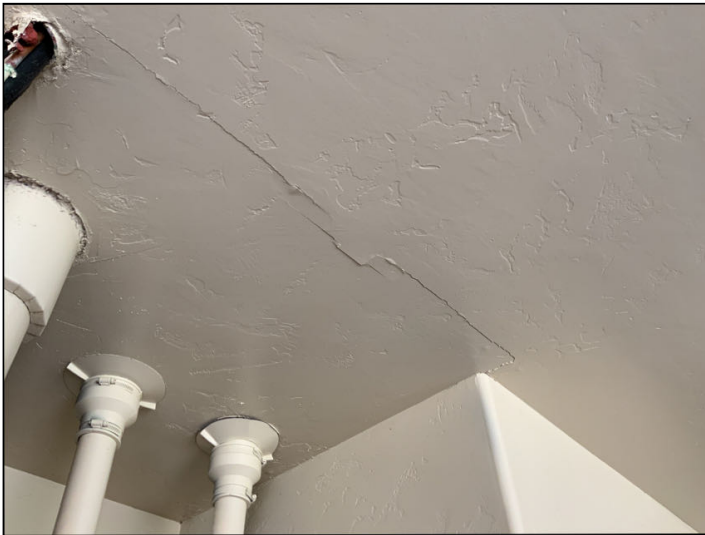
- Garage ceiling appeared satisfactory, at time of inspection. Except as noted.
- Typical cracks evident.
- Evidence of past repairs.
- Damage to drywall evident.

• Recommend review by a licensed contractor for repair.

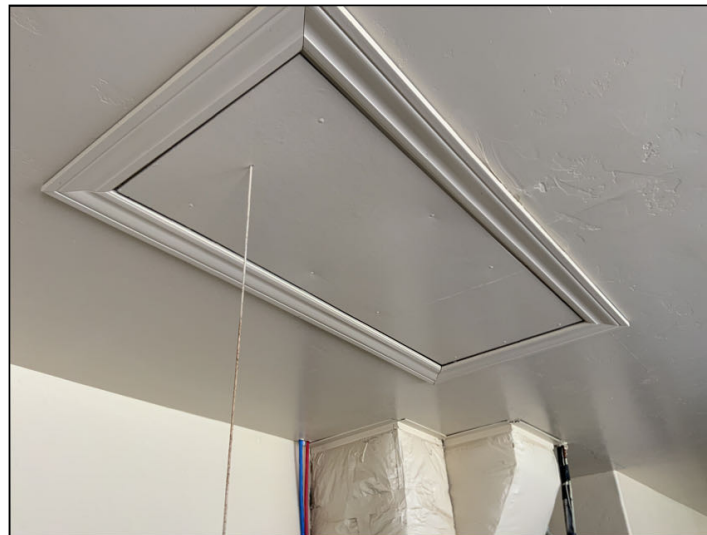
Evidence of past repairs.

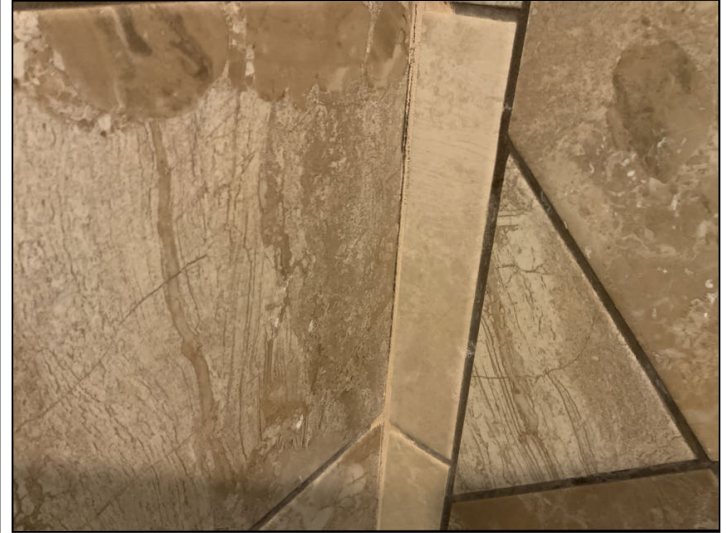
- Missing grout noted at tile.
- Recommend all tile edges and tub/shower walls be caulked and sealed to prevent moisture penetration.
- **Recommend caulking around all perimeter edges.**
- **Recommend qualified contractor repair/replace missing/damaged grouting.**

Missing grout noted at tile.

Recommend qualified contractor repair/replace missing/damaged grouting.

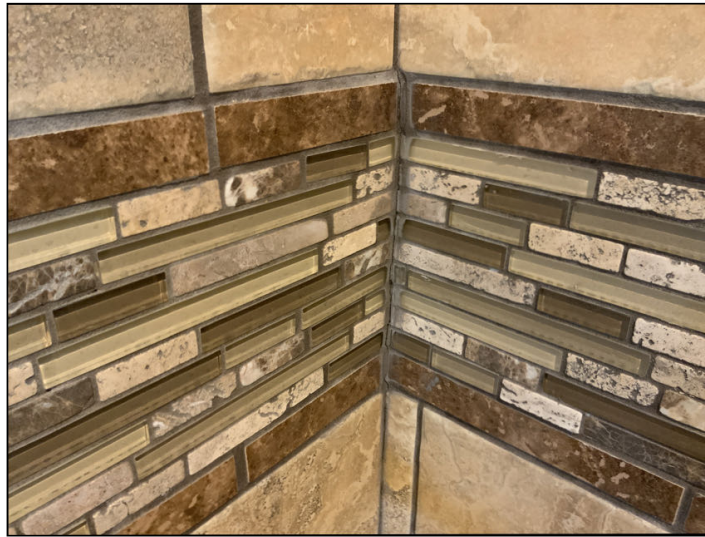
- **Missing grout noted at tile.**
- **Recommend all tile edges and tub/shower walls be caulked and sealed to prevent moisture penetration.**

Recommend all tile edges and tub/shower walls be caulked and sealed to prevent moisture penetration.

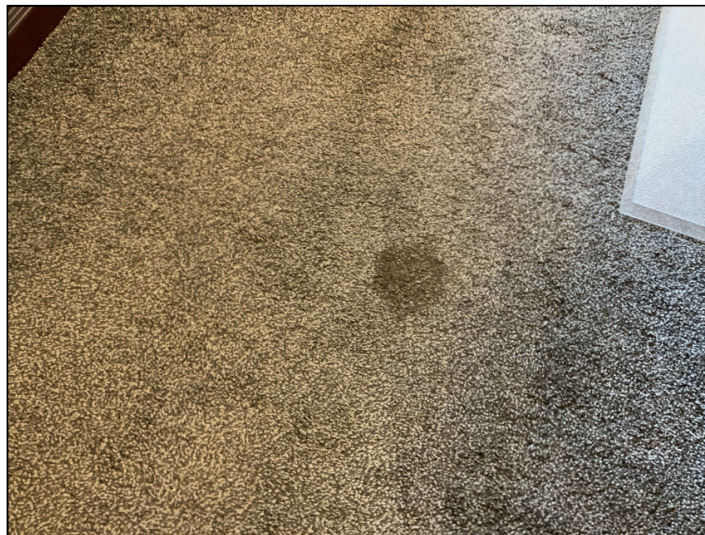
- Typical stains and wear observed.

Typical stains and wear observed.
