**Elite Home Inspections**  
A DIVISION OF  
*Elite Construction Services LLC*

# Property Inspection Report

5896 Greenview, Webster , NM 88569  
Inspection prepared for: Samuel Jones  
Real Estate Agent: Doe Jane - Exit Realty

Date of Inspection: 6/22/2022 Time: 10 AM  
Age of Home: 6 Size: 3600  
Weather: Cloudy

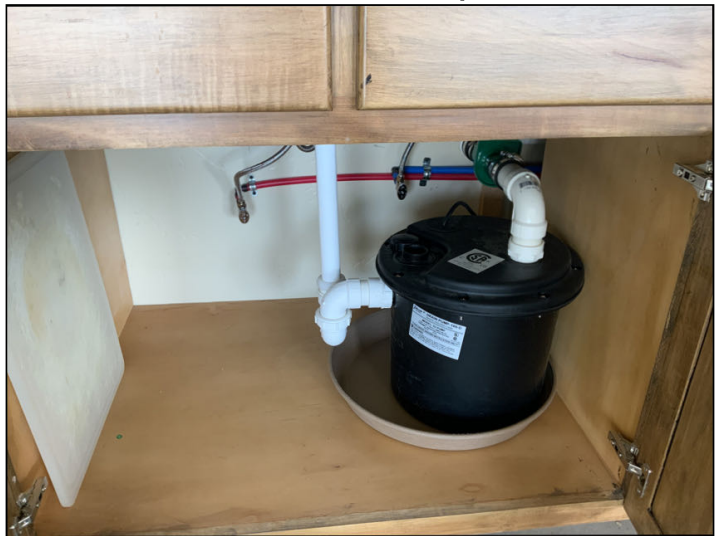
- Switches tested functioned satisfactory at time of inspection.
- Outlets tested functioned satisfactory at time of inspection.
- GFCI in place, functioned satisfactory at time of inspection.
- **Some outlets not accessible due to furniture and or stored personal items.**

Garage has sink with undercounter pump/grinder for drainage

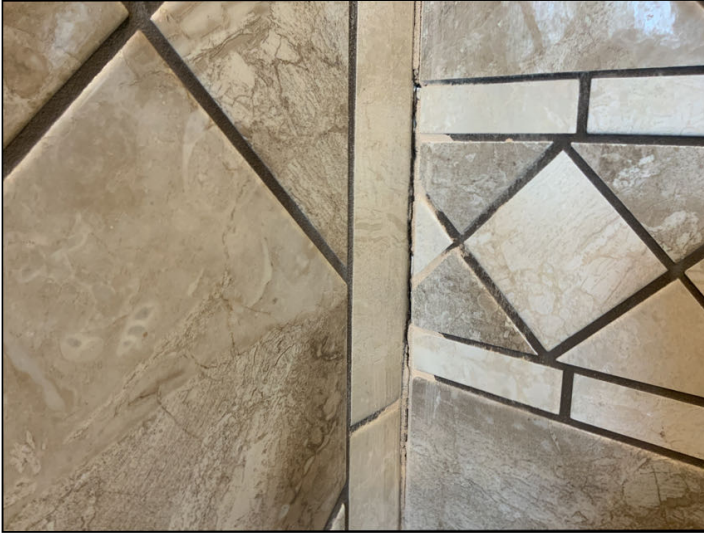
- Missing grout noted at tile.
- Recommend all tile edges and tub/shower walls be caulked and sealed to prevent moisture penetration.
- **Recommend caulking around all perimeter edges.**
- **Recommend qualified contractor repair/replace missing/damaged grouting.**

Missing grout noted at tile.

Recommend qualified contractor repair/replace missing/damaged grouting.

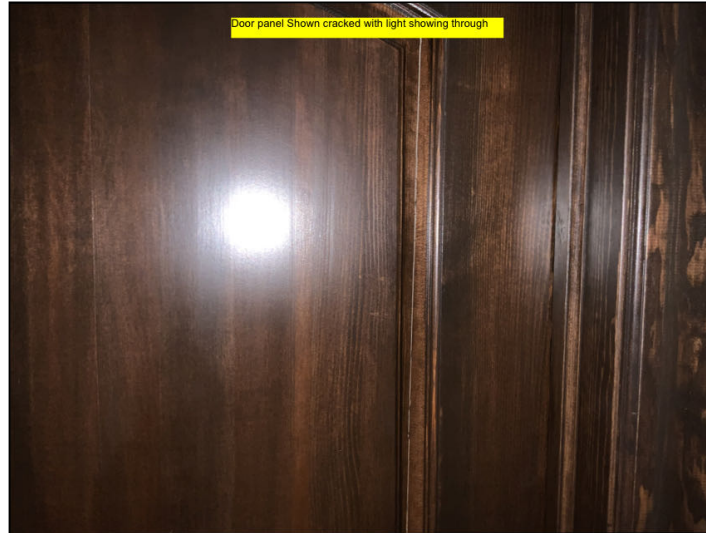
- Door Cracked and damaged

Door Cracked and damaged
