**Elite Home Inspections**  
A DIVISION OF  
*Elite Construction Services LLC*

# Property Inspection Report

5896 Greenview, Webster , NM 88569  
Inspection prepared for: Samuel Jones  
Real Estate Agent: Doe Jane - Exit Realty

Date of Inspection: 6/22/2022 Time: 10 AM  
Age of Home: 6 Size: 3600  
Weather: Cloudy

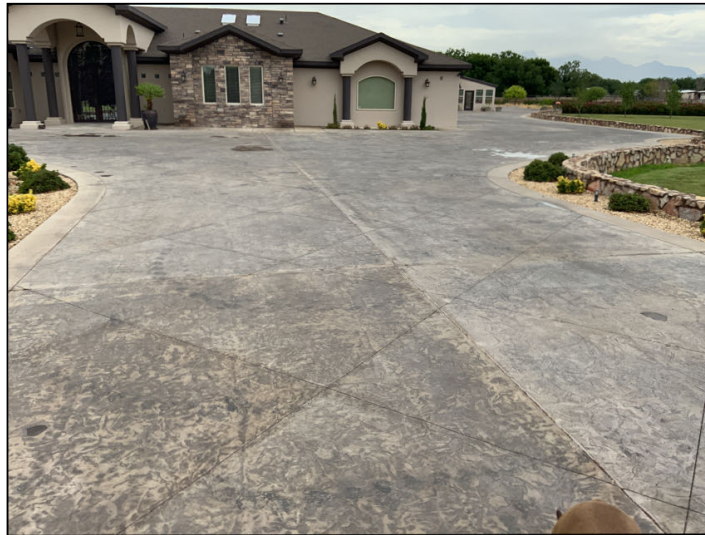
- Driveway appeared satisfactory at time of inspection.
- Driveway showed evidence of typical cracks and wear at time of inspection.

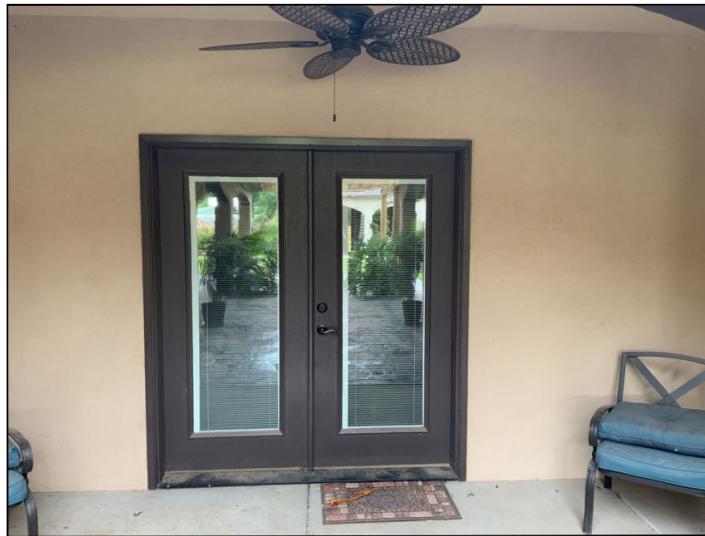
- Door in satisfactory condition at time of inspection.

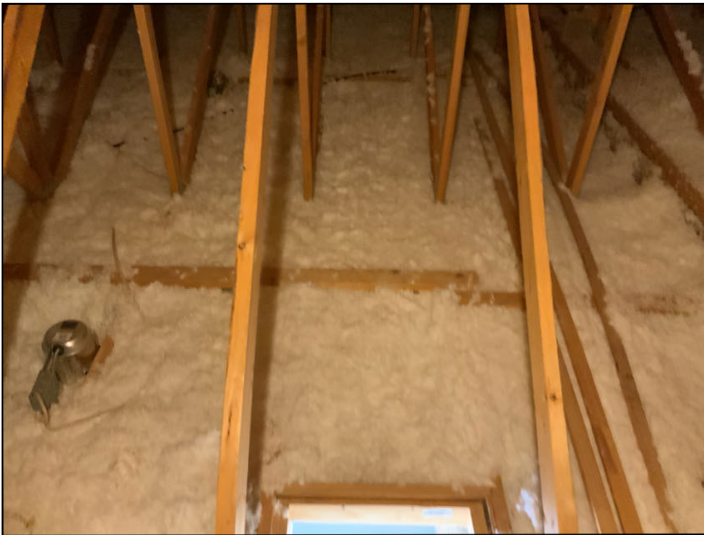
- Insulation is sparse in some areas.

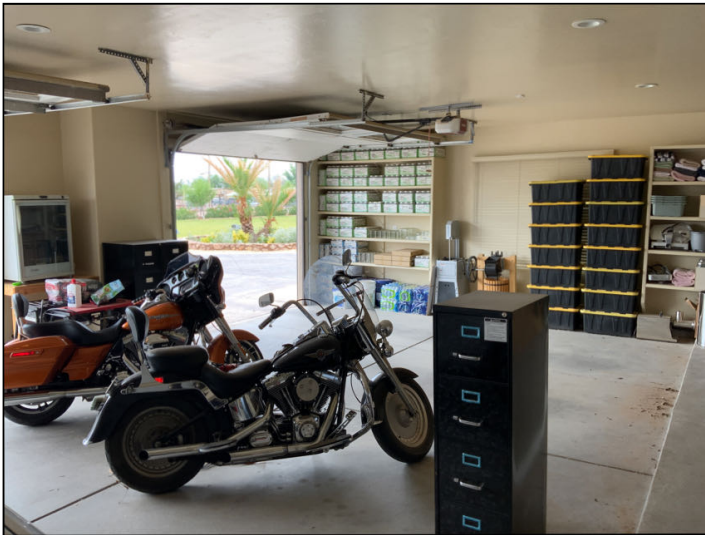
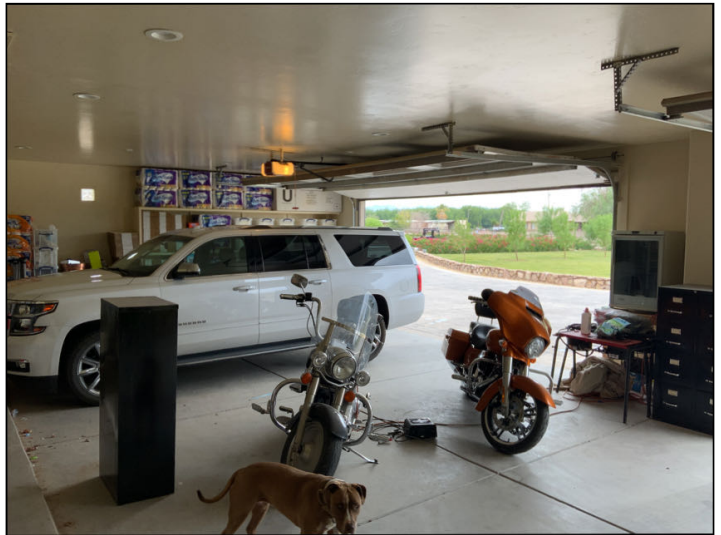
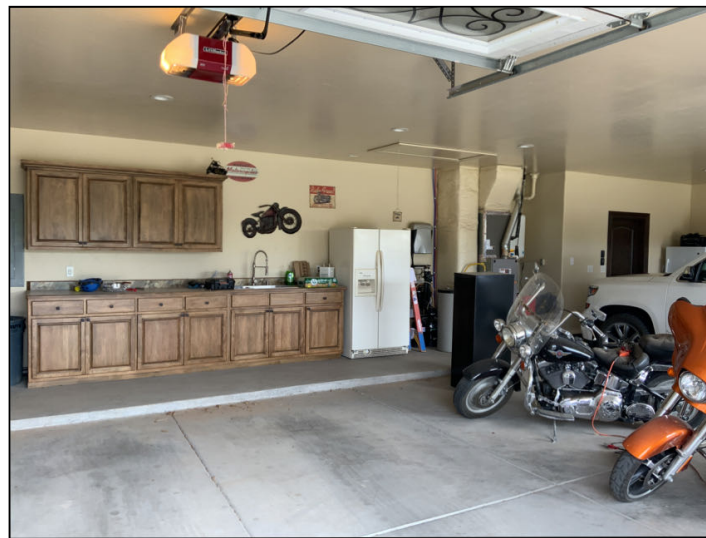
- Garage walls observed appeared satisfactory, at time of inspection. Except as noted.

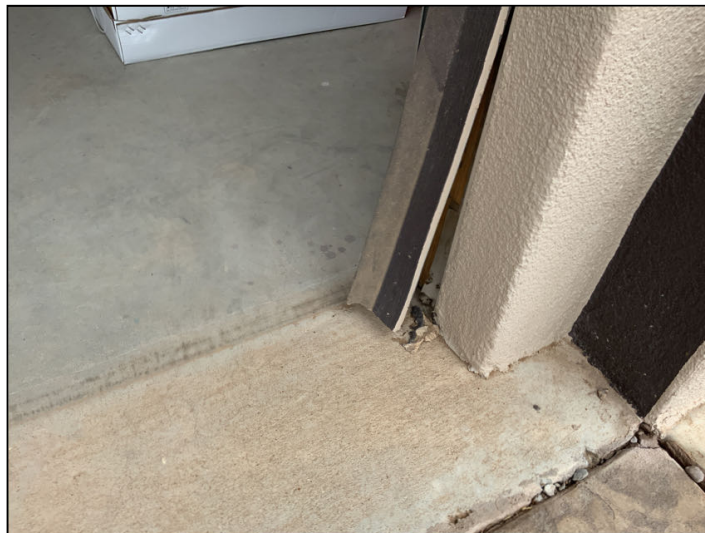
- The overhead door appeared and operated satisfactory at time of the inspection.
- Overhead door exterior trim is weathered/damaged.
- Eye beam sensor system operated satisfactory at time of inspection.

Overhead door exterior trim is weathered/damaged. Recommend scrape/prime/paint.

• Overhead door exterior trim is weathered/damaged. Recommend scrape/prime/paint.

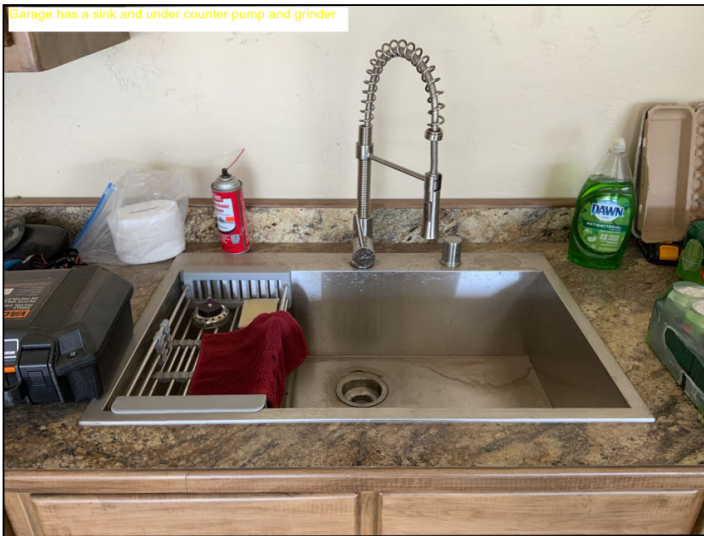
- Switches tested functioned satisfactory at time of inspection.
- Outlets tested functioned satisfactory at time of inspection.
- GFCI in place, functioned satisfactory at time of inspection.
- **Some outlets not accessible due to furniture and or stored personal items.**

Garage has sink with undercounter pump/grinder for drainage

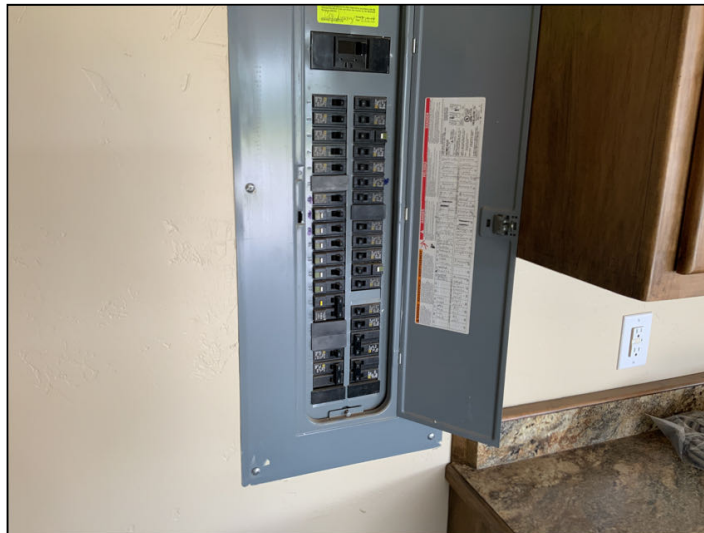
- Breaker box appeared safe and in satisfactory condition at time of inspection.
- System appeared properly grounded at time of inspection.
- Circuit breakers properly labeled.
- GFCI Breakers present. Recommend periodic testing.
- AFCI Breakers present. Recommend periodic testing.

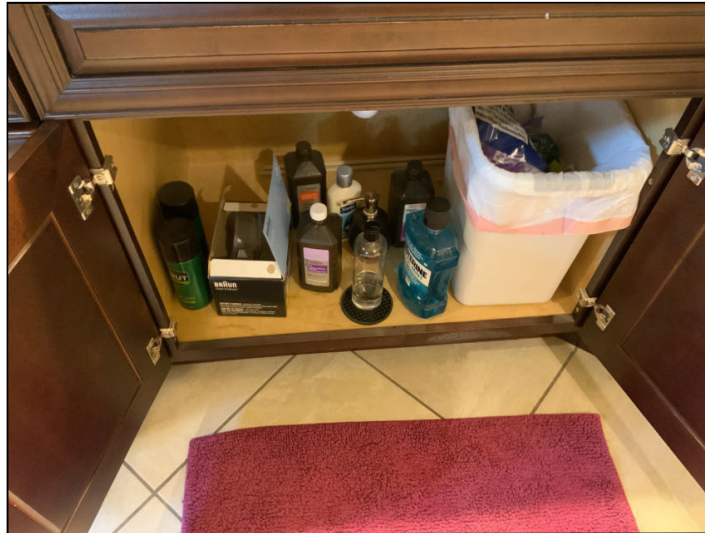
- Sink was observed in satisfactory condition.
- Faucet operated satisfactory at time of inspection.
- Limited review due to personal property stored in undersink cabinet.

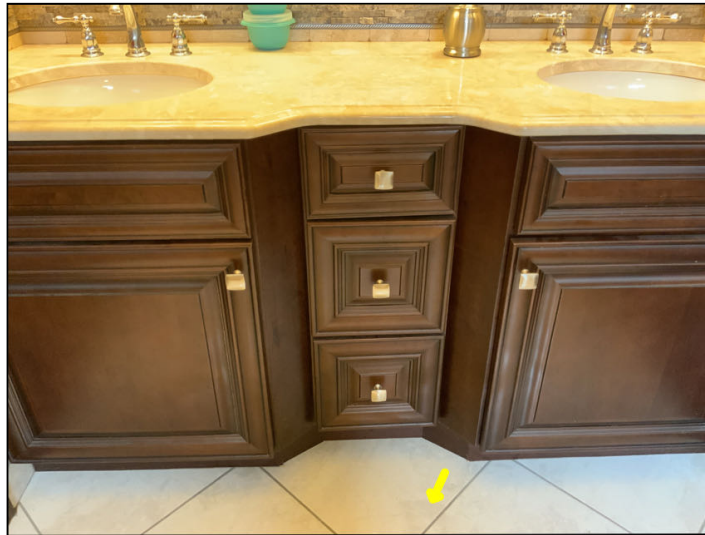
- Cabinets, doors and drawers appeared functional and in satisfactory condition at time of inspection.
- Counter tops appeared in satisfactory condition at time of inspection.
- Some cabinets, doors and drawers not fully accessible due to stored personal items.
- Recommend sealing backsplash area(s).

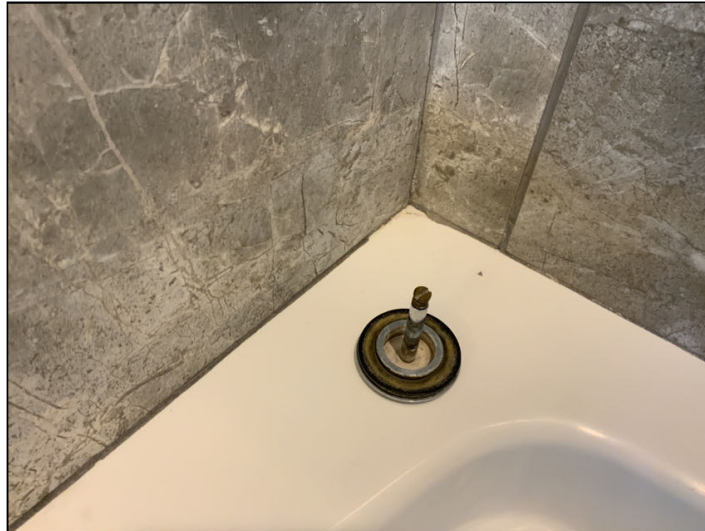
- The whirlpool tub and surround appeared satisfactory at the time of the inspection.
  - Water flow at the tub appeared satisfactory at the time of the inspection.
  - Functional drainage of the tub appeared satisfactory at the time of the inspection.
  - Motor briefly activated to ensure motor was serviceable. Tub was not filled to test water flow through jets.
  - Access panel present, NOT removed during inspection.
  - GFCI for whirlpool tub not visible.
  - Recommend caulking around all perimeter edges.
- Recommend caulking around all perimeter edges.

Recommend caulking around all perimeter edges.

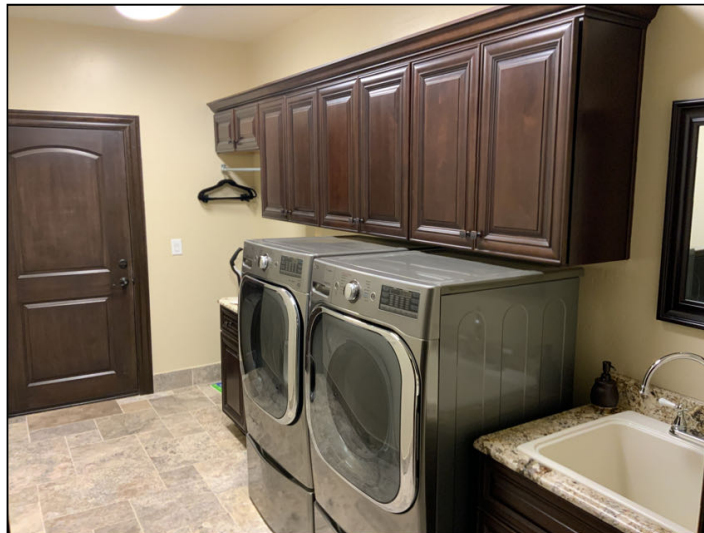
- Walls appear in satisfactory condition at time of inspection.

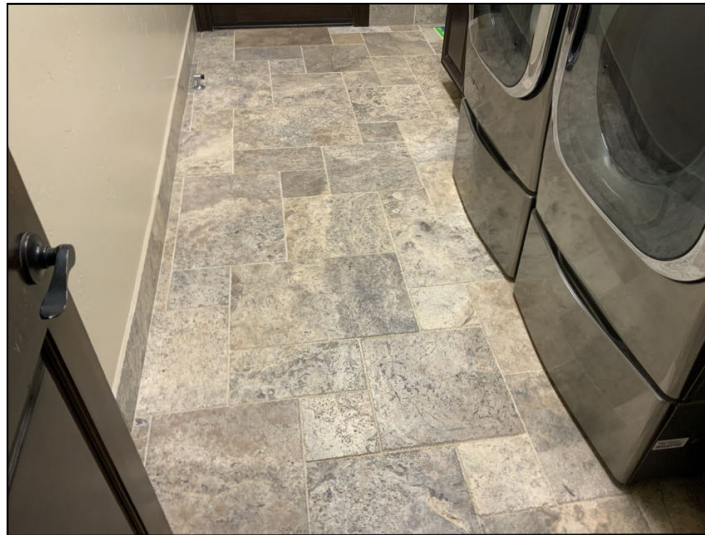
- Floors appear to be in satisfactory condition at time of inspection.

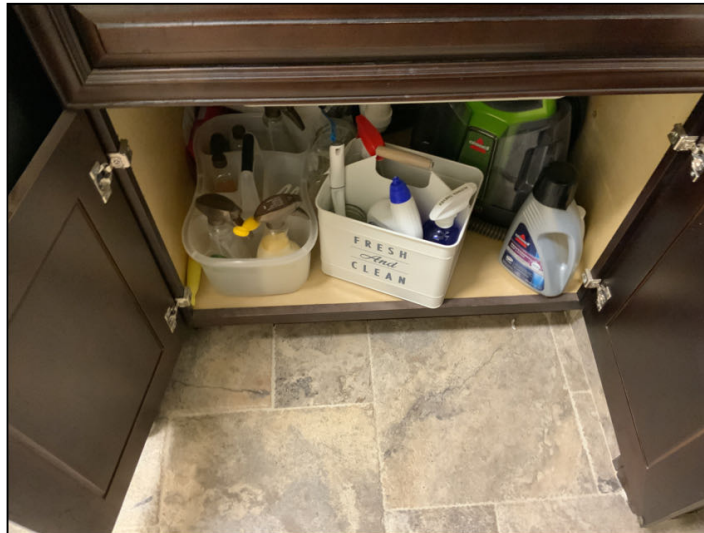
- Water pressure/flow were observed as satisfactory.
- Sink was observed in satisfactory condition.
- Faucet was observed in satisfactory condition.
- Faucet operated satisfactory at time of inspection.
- Functional drainage was satisfactory at time of inspection.
- Limited review due to personal property stored in undersink cabinet.

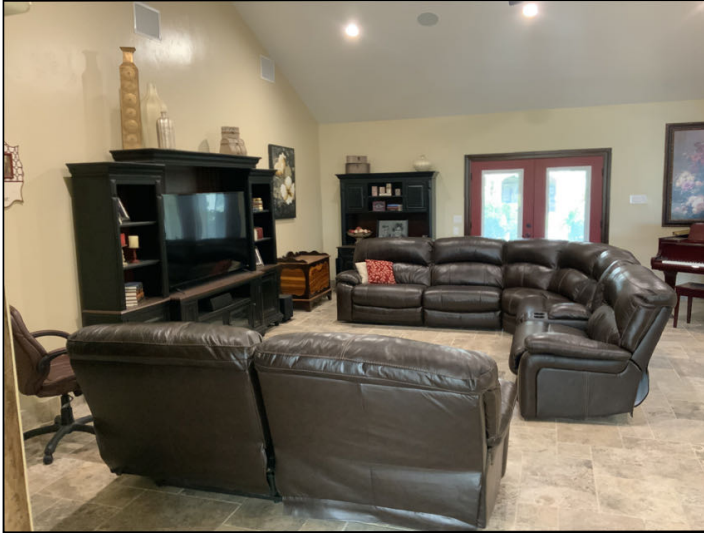
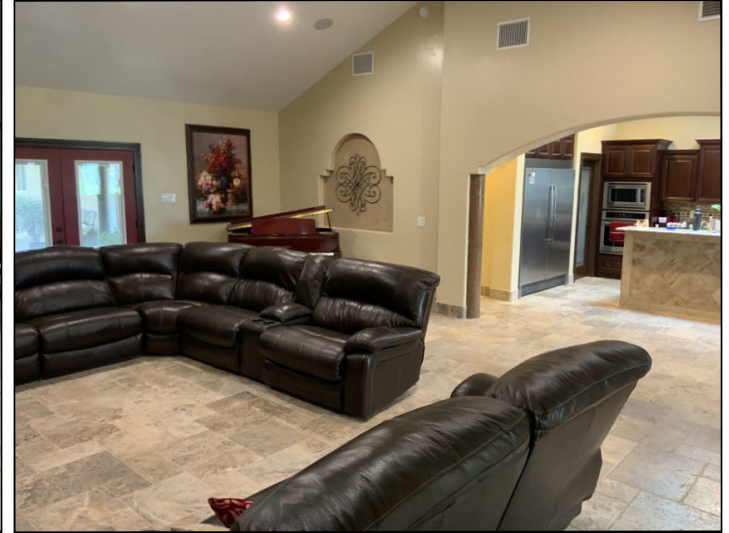
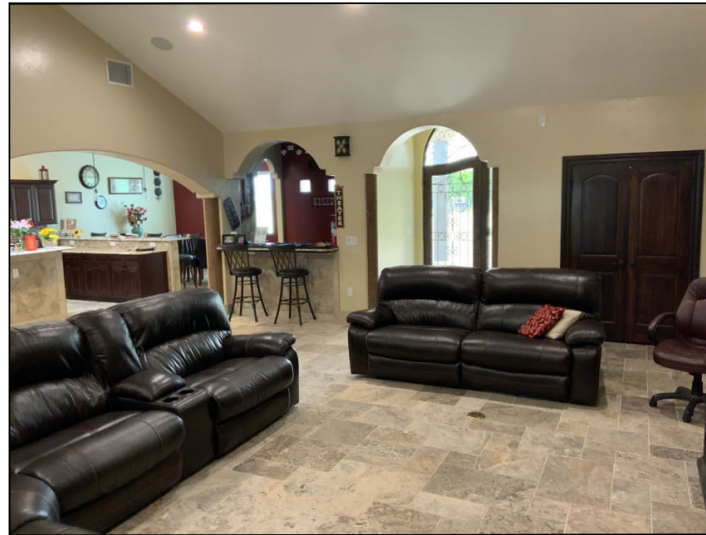
- Walls appear in satisfactory condition at time of inspection.

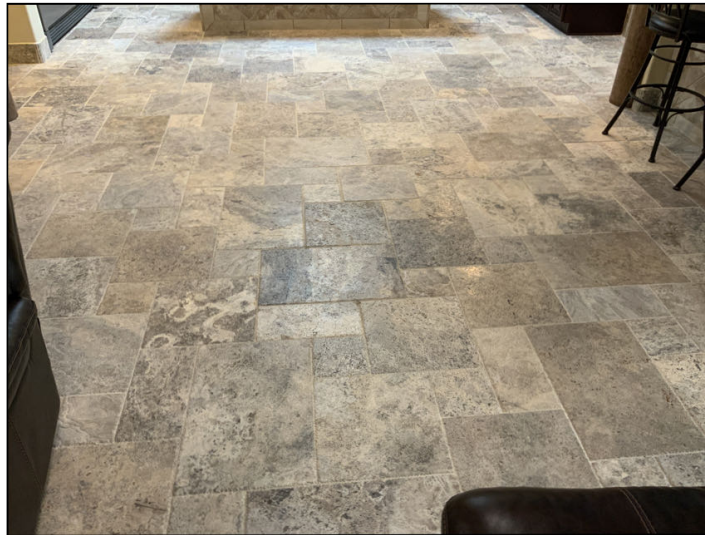
- Floors appear to be in satisfactory condition at time of inspection.

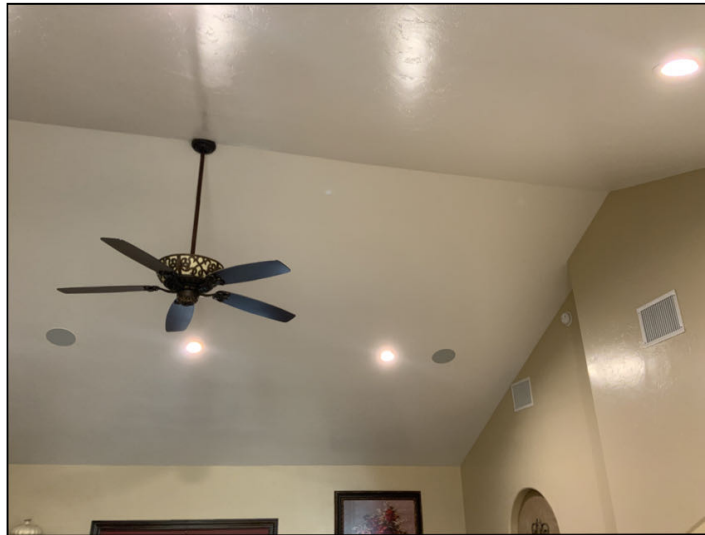
- Ceilings observed to be in satisfactory condition.

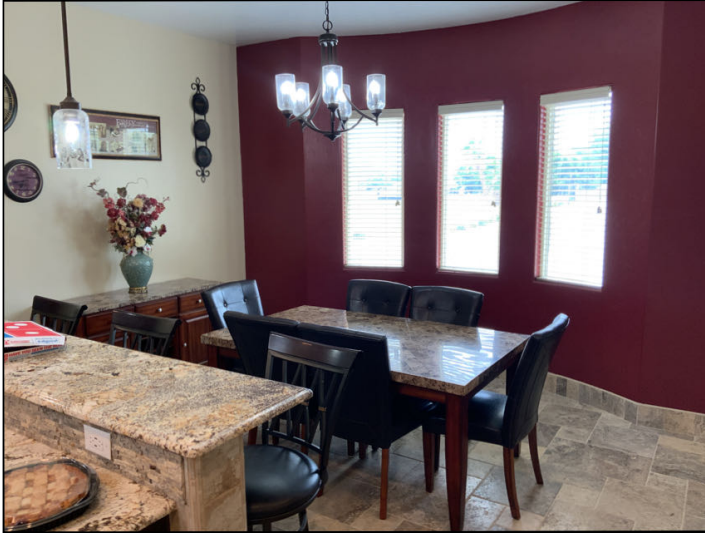
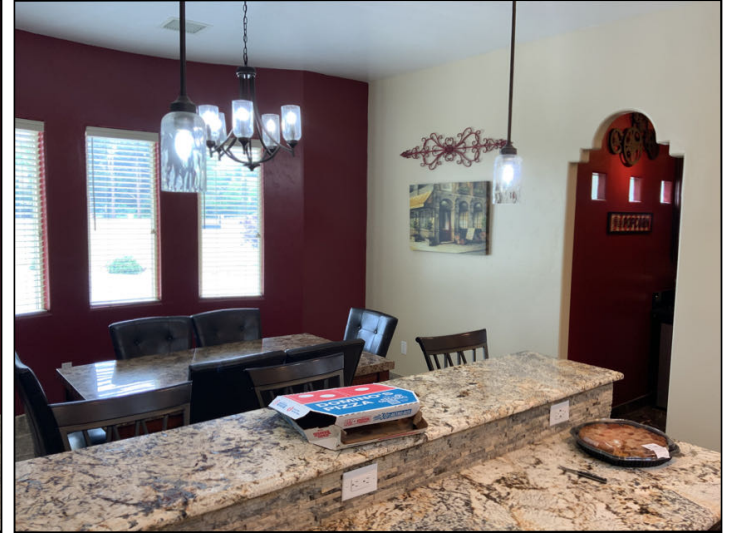
- Walls appear in satisfactory condition at time of inspection.

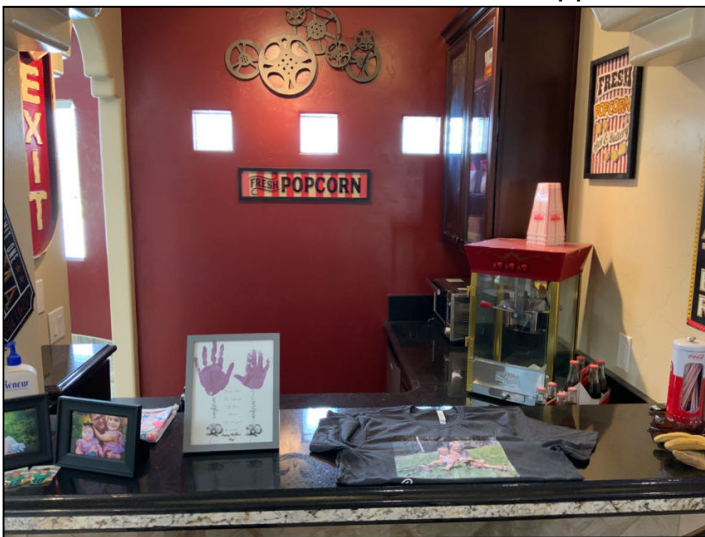
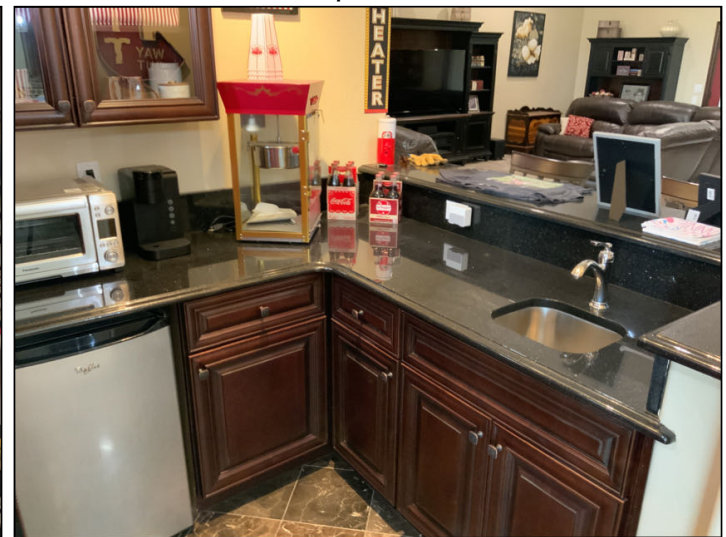
- The bar area appears functional at the time of inspection.
